Armstrong York
Asbestos Environmental Ltd

Reinspection Survey
Survey Report

147-149 Glanville Road, SW12 ONL

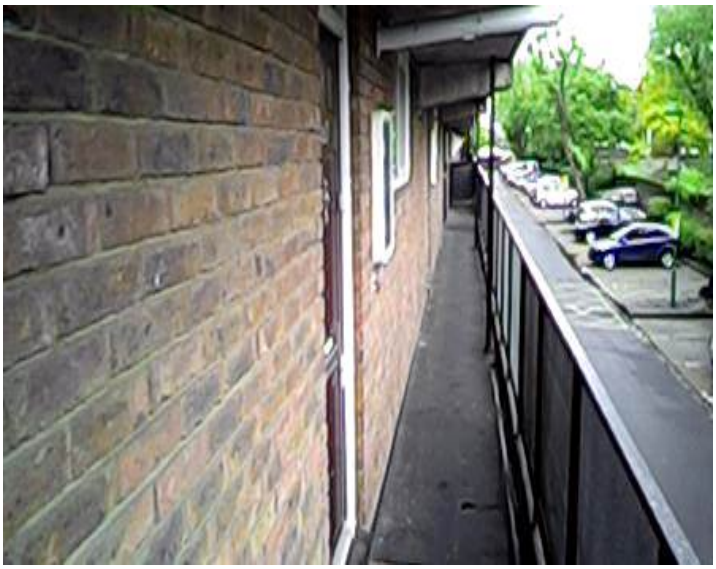
Sample Ref No.	Register /Item No.	Area/ Building	Floor	Room/Item & Location	Extent	Likelihood of Disturbance		Material Assessment				Material Assessment Score (2-12)	Recommendations
						Amount	Accessibility	Product Type (1-3)	Damage/ Condition (0-3)	Surface Treatment (0-3)	Asbestos Type (1-3)		
Visual	1	- 001 Walkway 01	0 - Ground	1 NSMF		-	-	-	-	-	-	-	No further action required
